Another Problem Solved by PipeServ

Location: Melbourne, Australia

Application: Air Supply Line Repairs

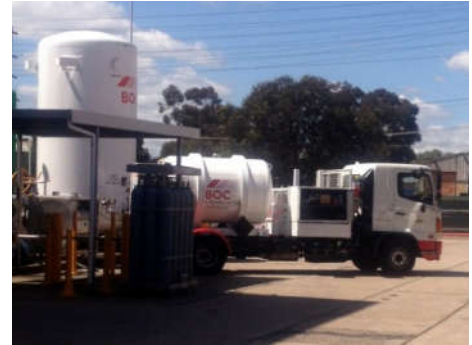
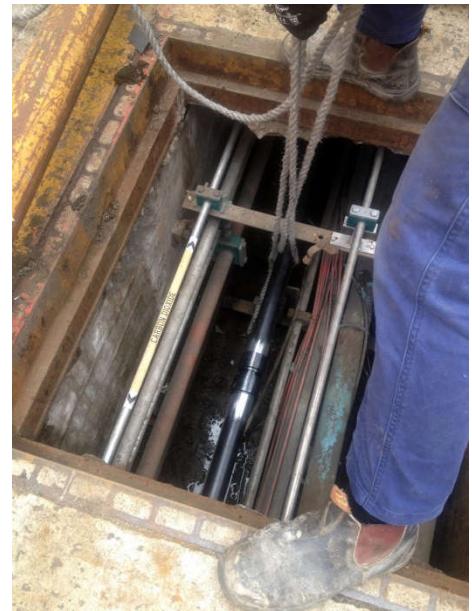
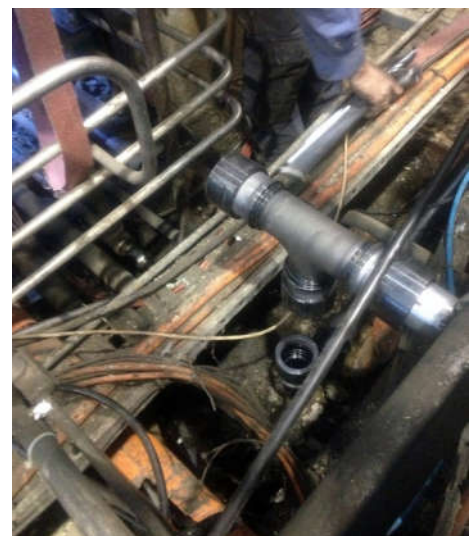
PipeServ was asked to urgently assist in getting this production facility back into operations. This was a large gas production and bottling site had lost all operations when the main instrument-air supply line leaked due to corrosion. The pipeline was one of many running through below ground pits but this one had been sitting on the ground resulting in external corrosion and eventually failed. This being the main supply line; the whole site lost air and all production ceased.

The Production Manager was aware of Lokring and contacted PipeServ for assistance. We were promptly on-site with Lokring fittings, tooling and qualified manpower to complete the repair. In all, over 20m of corroded pipe was replaced using Lokring couplings, elbows, tees and caps.

Lokring fittings proved invaluable as welding pipe in these highly congested pits was not possible. Pipe threading was considered but Lokring proved to be much faster, easier and no leaks. Operations were able to commence sooner and production losses minimised.
