Another Problem Solved by PipeServ

Location: Papua New Guinea

Application: Pipeline Dent Encapsulation

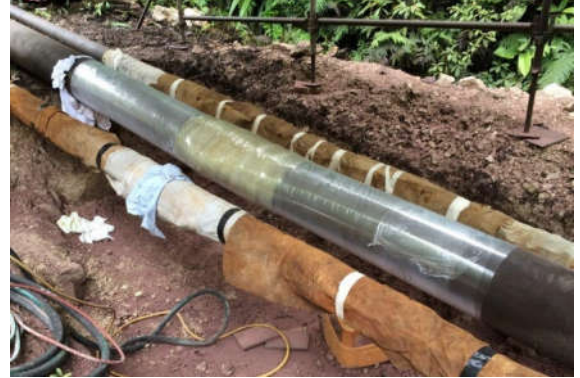
PipeServ was able to offer a solution in repairing of a pipeline with a large dent (caused by a falling tree). This DN350 trunkline was highly productive and could not be shut-down to allow for pipe cutting and welding without causing significant revenue losses.

CLOCK SPRING WAS APPLIED, AT THE TIME, AS AN EMERGENCY REPAIR.

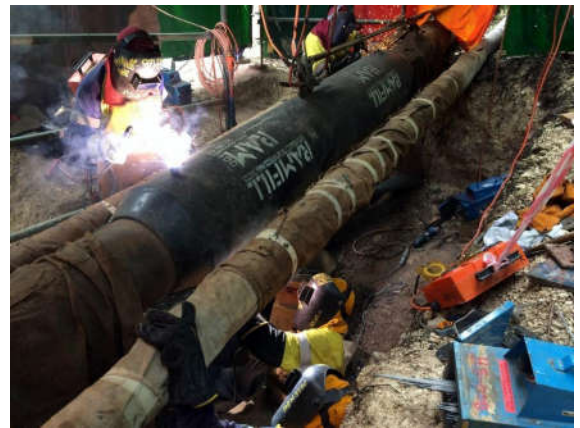
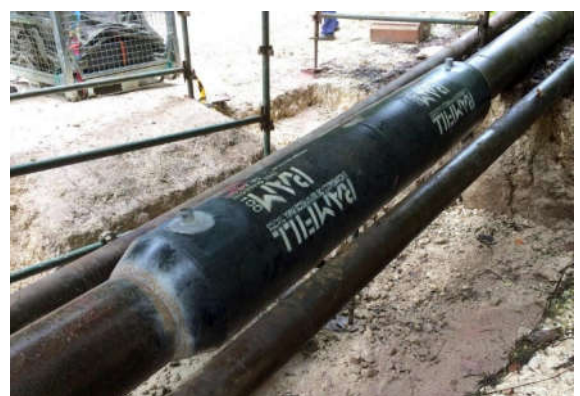
RAMFILL SLEEVE FULLY INSTALLED: WELDED, NDT INSPECTED & FILLED WITH RAM LIQUID EPOXY.

The sleeve needed to allow for the large dent which also caused pipe ovality over a wide area. The sleeve was custom manufactured to suit; resulting in a 3.0m long sleeve and with DN500 enlarged body section. Once welded; the sleeve will be filled with 100% solids liquid epoxy, filling the annulus between pipe and sleeve.

The RAMFILL Repair Sleeve provided full encapsulation repair of the dent and is rated to the pipeline design pressures and temperatures as specified by the client. The epoxy filler is multi-purpose; providing for corrosion protection, leak sealing and for load transfer of pipeline to sleeve. This repair is permanent, completed on-line and no loss of production.
