Another Problem Solved by PipeServ

Location: Victoria, Australia

Application: Pipeline Dent Repairs

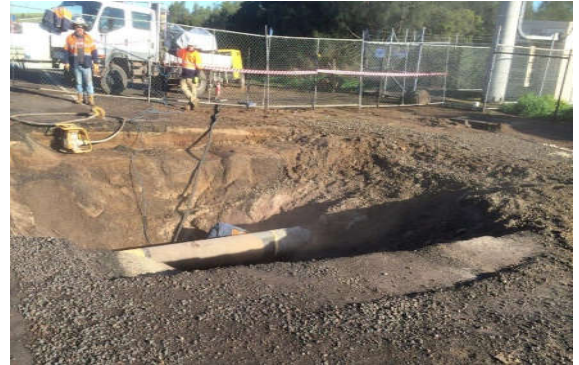
PIPELINE BEING GRIT BLASTED

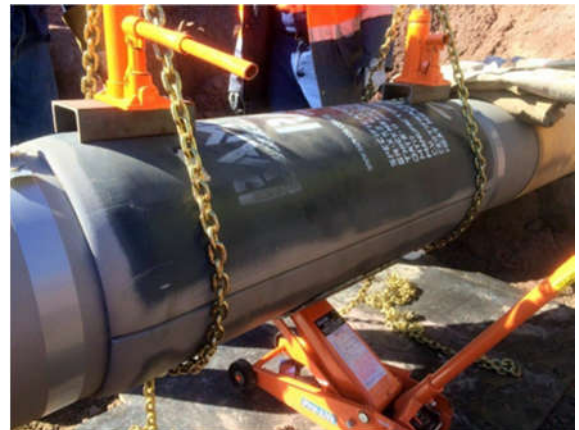
SLEEVE FIT-UP PRIOR TO WELDING

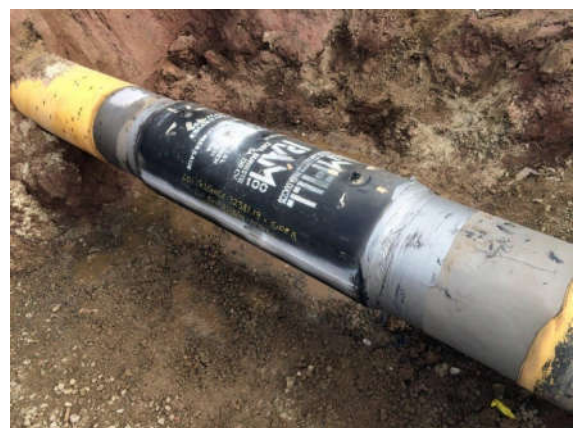
RAMFILL SLEEVE FULLY INSTALLED: WELDED, NDT INSPECTED & FILLED WITH RAM LIQUID EPOXY.
