## Another Problem Solved by PipeServ

**Location: Western Australia**

### Application: Ammonia Lines (4 off) Repaired

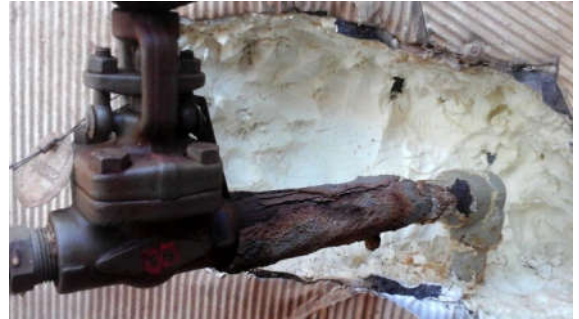
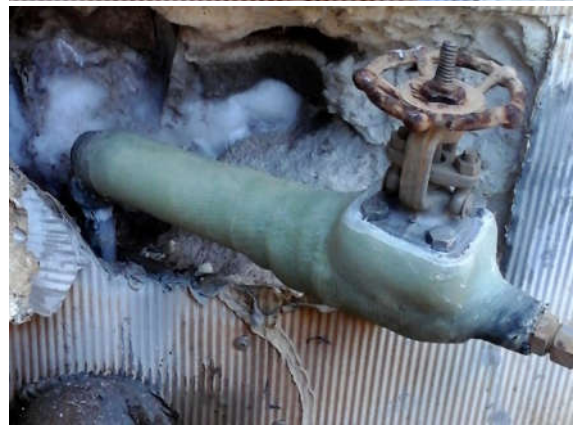
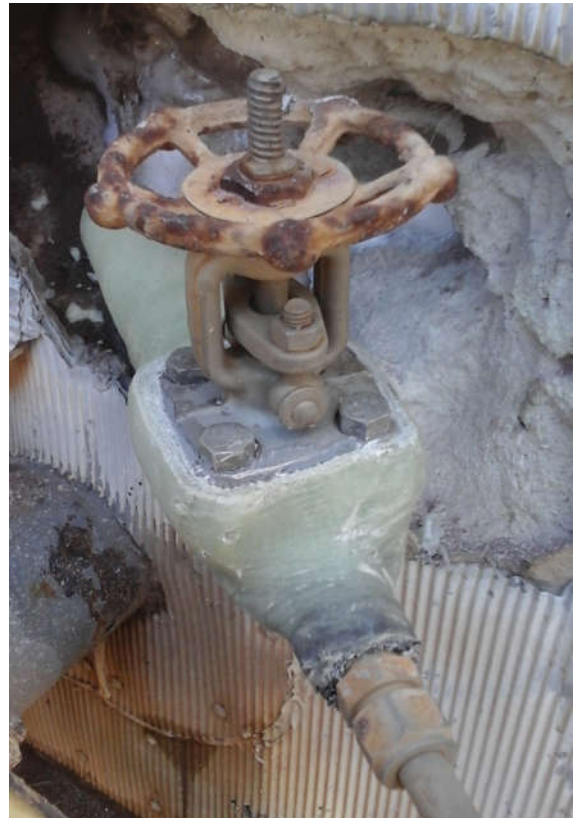
PipeServ was able to offer a permanent repair on liquid ammonia storage tank piping. The facility Inspection Group had conducted CUI (corrosion under insulation) inspections and detected that four small bore pipes had severe wall loss. These pipes required repair before any leaks occurred which would have caused a major incident and facility shutdown.

The solution offered by PipeServ was for the application of ClockSpring|NRI Contour wrap. Contour is an engineered composite pipeline repair wrap, applied under a cold permit. Engineering was conducted to determine the repair design; confirming the number of wraps and the length of repair required to meet the design pressure and temperature.

With insulation removed, the piping was grit blast clean to a SA2.5 finish. The surface profile then confirmed to meet specified roughness for adhesion and leak sealing. ClockSpring|NRI Contour was supplied and installed by PipeServ as per engineering specifications and procedures. The ClockSpring|NRI composite wraps are able to provide for a permanent repair and engineered to meet the pipeline design pressures and temperatures.
