## Another Problem Solved by PipeServ

**Location: Offshore Western Australia**

**Application: Flare Line – Offshore Facility**

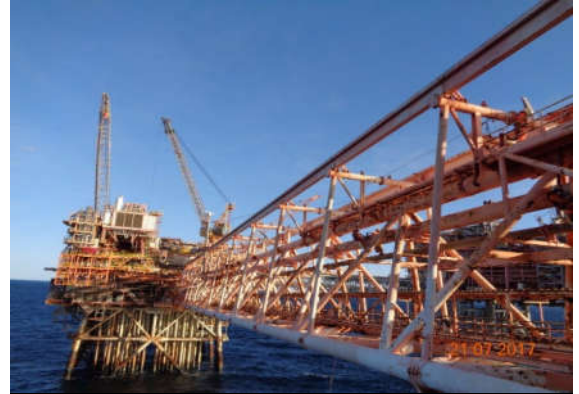
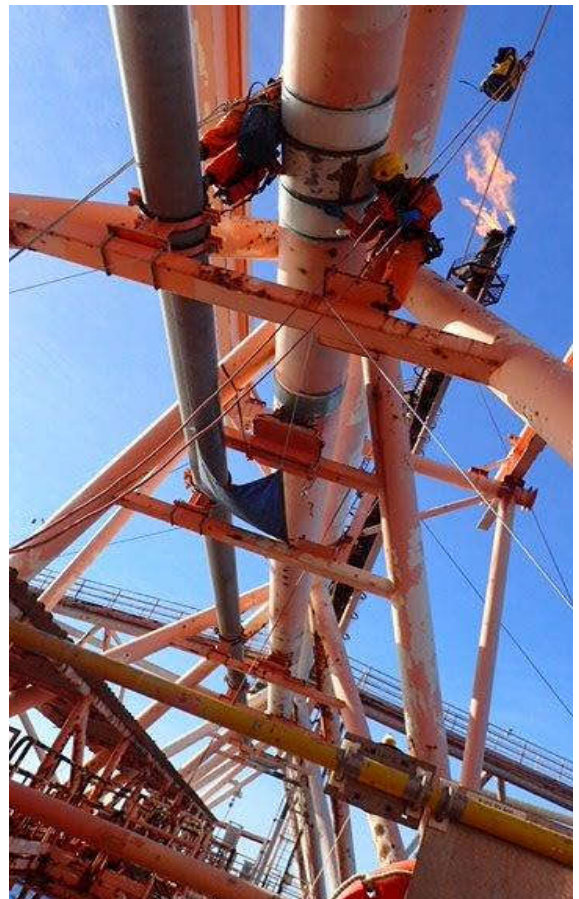
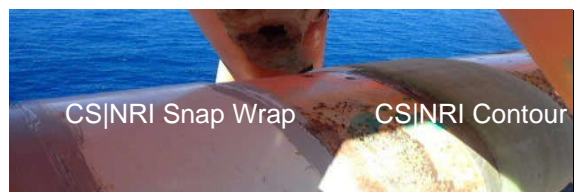
PipeServ was able to offer a permanent repair solution to this 30” HP Flare Blow Down Line. Inspection of this line found a large number of corrosion blisters that (on further inspection) were confirmed as requiring repair to prevent the possibility of a leak and unplanned facility shutdown.

This pipeline transports flare gases and cannot be taken offline for repair. Radiant heat from the flare meant that any repair must also be capable of withstanding these high temperatures. Another issue when working on this flare line is that all workers must be able to evacuate quickly should a flare be triggered. Add to this the available access meant all work (pipe cleaning, repair application and re-coating) had to be completed by rope access technicians.

Due to the location of the anomalies, some being adjacent to pipe shoes/supports, we elected to use both ClockSpring|NRI Snap Wrap and Contour composite wraps. Snap Wrap on straight pipe sections and Contour when we needed the flexibility of wrapping over or around these pipe shoes.

Both products exceeding pipeline design pressures and temperatures. ClockSpring|NRI Snap Wrap composite wrap is rated for a design life of 50 years while the ClockSpring|NRI Contour wrap has a 20yr design life. The whole exercise being completed on-line, with no incidents or near misses.
