## Another Problem Solved by PipeServ

**Location: Offshore Facility, Australia**

**Application: Fuel Gas Line – Leak Repair**

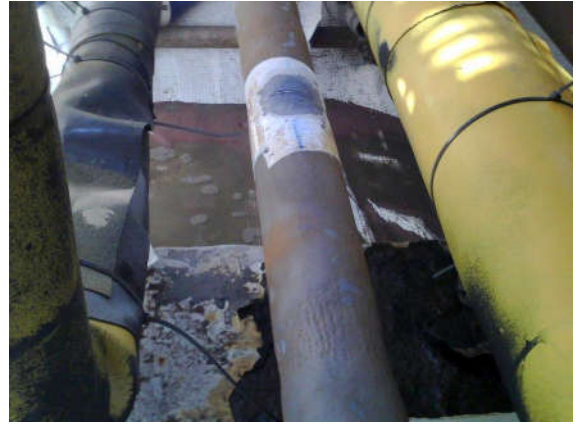
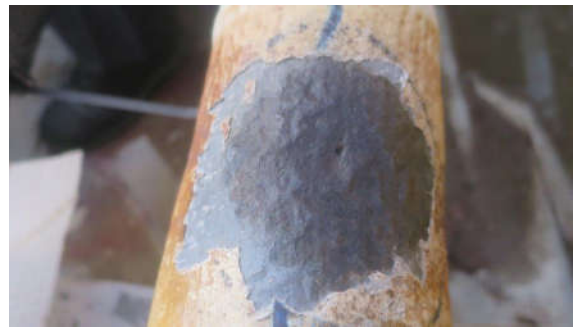
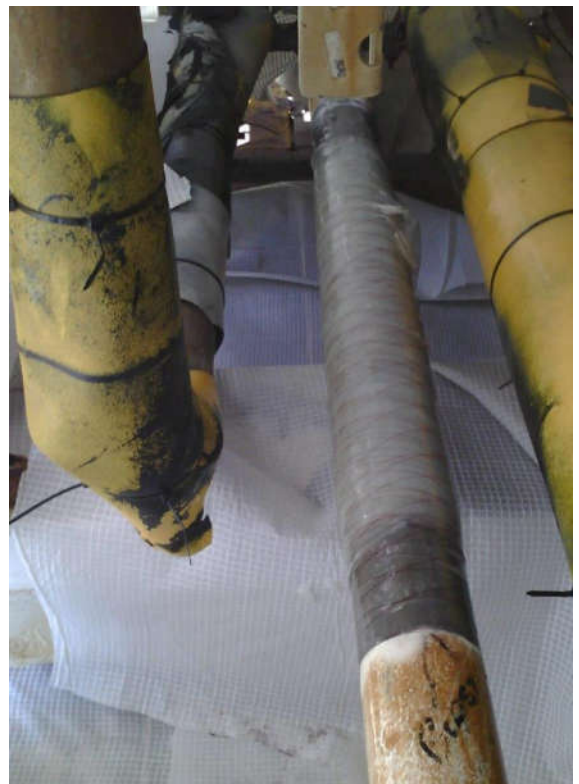
PipeServ was able to offer a solution for the repair of a fuel gas line on an offshore facility. This line had suffered from external corrosion, resulting in a leak. On inspection, more external corrosion was recorded close to the leak (this anomaly also requiring repair).

The solution offered by PipeServ was for the application of ClockSpring|NRI Contour wrap. Firstly addressing the leak using ClockSpring|NRI Leak Stop technology (which plugs and seals the hole). This then allows for the pipe preparation and filling of further external wall loss to ensure load transfer from the pipe to the composite wrap. ClockSpring|NRI Contour wrap was then applied as per specifications and procedures.

1. Temporary shutdown of pipeline.
2. Apply ClockSpring|NRI Leak Stop to the hole.
3. Pipe preparation (grit blasting and cleaning).
4. Apply a metal epoxy to any corrosion / wall loss.
5. Install ClockSpring|NRI Contour to the repair area.
6. Recoat the pipeline and ClockSpring|NRI Contour.
