## Another Problem Solved by PipeServ

**Location: Offshore Facility, Australia**

**Application: Fuel Gas Line Repair**

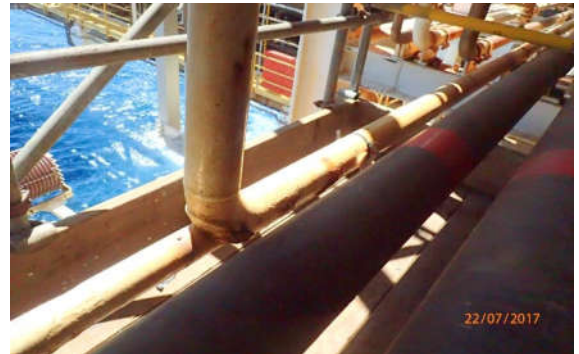
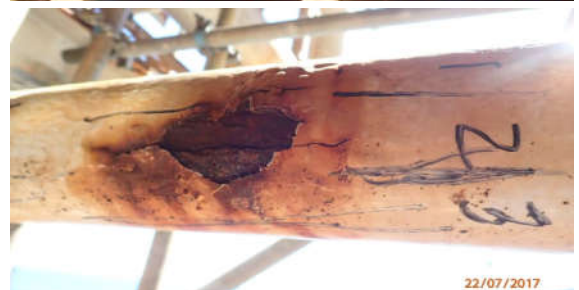
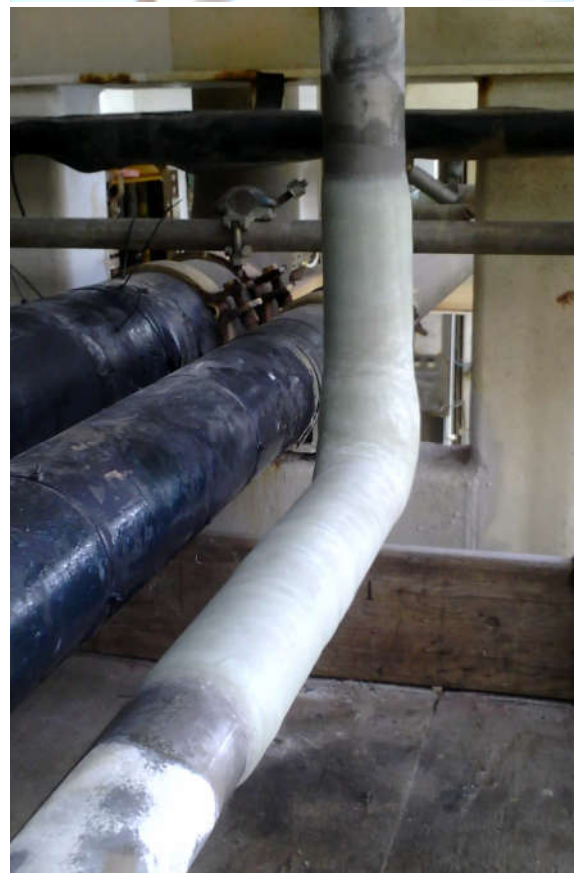
PipeServ was able to offer a solution for the repair of a fuel gas line on an offshore facility. After the review of NDT inspection reports, it was confirmed the external wall loss was significant and would require repair to allow for continued operations.

The decision was to repair this pipeline using the ClockSpring|NRI Contour composite wrap (as opposed to cutout) as this repair could be completed online. Engineering was conducted to confirm the repair design, the number of wraps and the length of repair required to meet the pipeline design. This engineering accounts for the pipe materials, pipeline product, design pressure, design temperature and nominated operational life.

ClockSpring|NRI Contour was supplied and installed by PipeServ Technicians to comply with engineering design, procedures and clients permit requirements.
