Another Problem Solved by PipeServ

Location: New South Wales, Australia

Application: Gas Distribution Pipeline

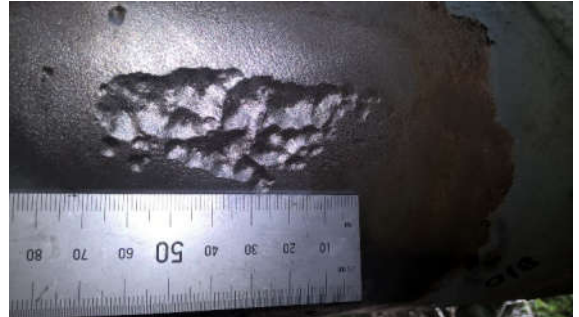
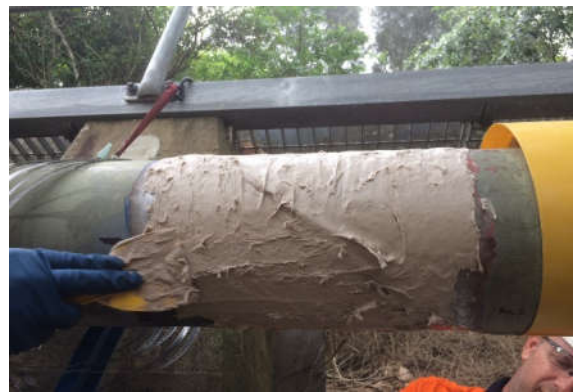
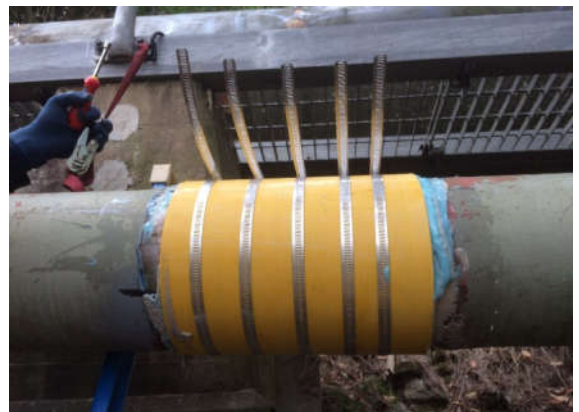
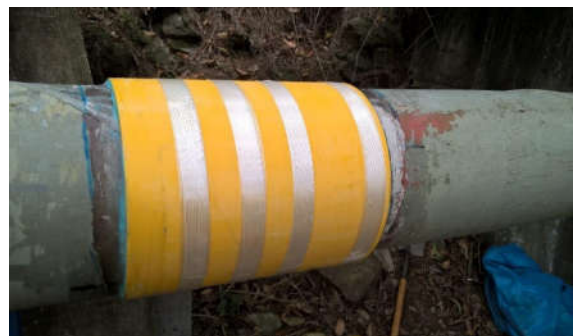
PipeServ continue to offer permanent repair solutions for the repair of gas distribution pipelines. This corrosion anomaly, when measured and assessed by Engineering, confirmed that the pipeline would require repair to comply with pipeline operating and design conditions.

Nominal Pipe Size:	DN200
Nominal Wall Thickness:	4.78mm
Wall Loss:	3.70mm
Operating Pressure:	1050kPa

PipeServ supplied and installed ClockSpring|NRI Snap Wrap as per installation procedures. Applying filler to the wall loss and each side of the seam weld, prior to fitting the four layers of ClockSpring|NRI Snap Wrap. Stainless steel straps are used to secure in place until cured (2hrs) and can be removed.

PipeServ Technicians completed the installation within two hours and the repair has since been coated using the StopAq pipeline tape coating system to protect against any further corrosion.
