Another Problem Solved by PipeServ

Location: Queensland, Australia

Application: Crude Oil Line – Leak Repair

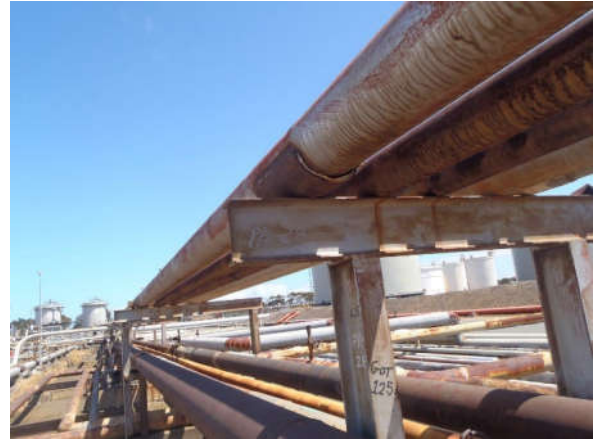
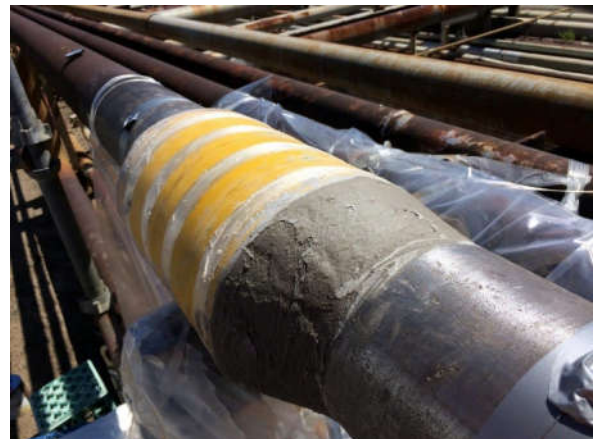
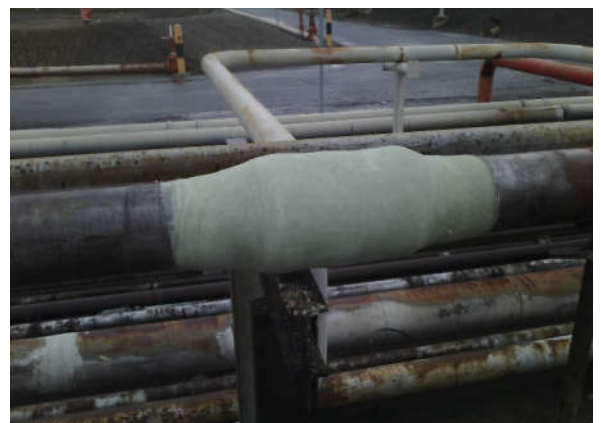
PipeServ was able to offer a solution for the repair of a leaking light crude oil (LCO) line. External corrosion had caused a leak at a pipe support on the LCO line.

CLOCKSPRING | NRI® SNAP WRAP AND
CONTOUR INSTALLED TO REPAIR
LEAKING CRUDE OIL PIPELINE.

1. Install a plug to the pipe leak.
2. Apply a metal epoxy over this plug.
3. Install a pipeline leak repair clamp.
4. Pipe cleaning and preparation for Snap Wrap.
5. Install ClockSpring|NRI Snap Wrap over the clamp.
6. Apply epoxy filler to taper from Snap Wrap to pipe.
7. Install ClockSpring|NRI Contour to the repair area.
