Another Problem Solved by PipeServ

Location: Queensland, Australia

Application: CSG Pipe Spool Repair

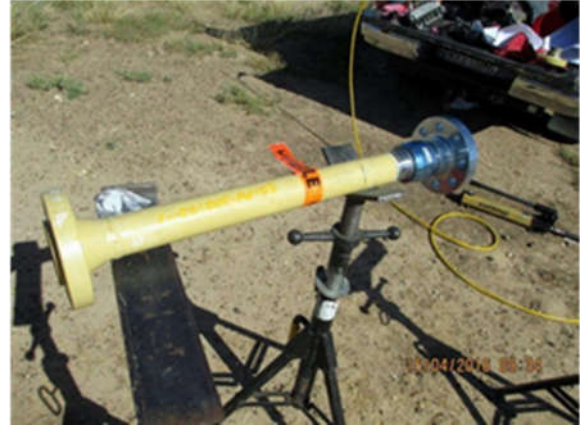
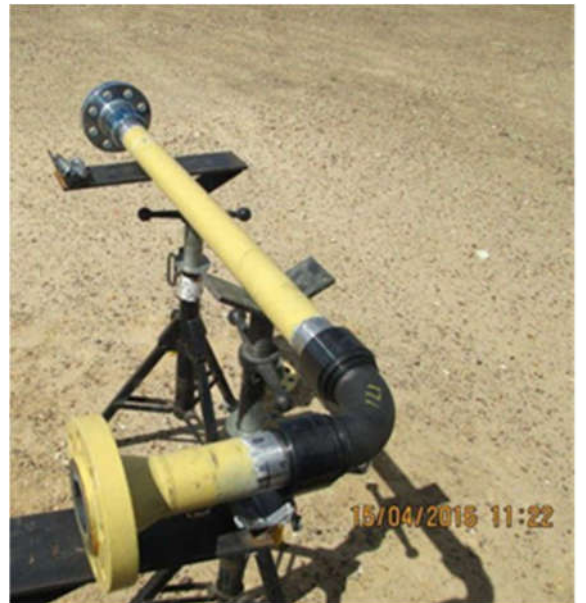
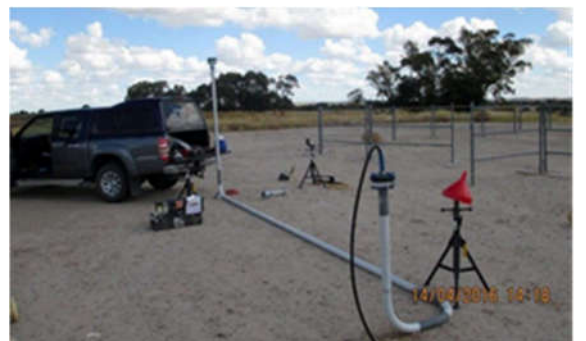
LOKRING FITTINGS INSTALLED & PIPE SPOOLS HYDRO-TESTED ON-SITE.

The traditional method of repair was replacement using newly fabricated spools but this was costly and we were asked for an alternative. Our solution was for the repair rather than replacement, using Lokring fittings. The use of Lokring fittings allowed these spools to be removed, repaired / modified and hydro-tested without leaving site. Another major benefit was that the work could be completed under a cold work permit.
