Another Problem Solved by PipeServ

Location: Papua New Guinea

Application: Leak Repair to Gas Injection Line

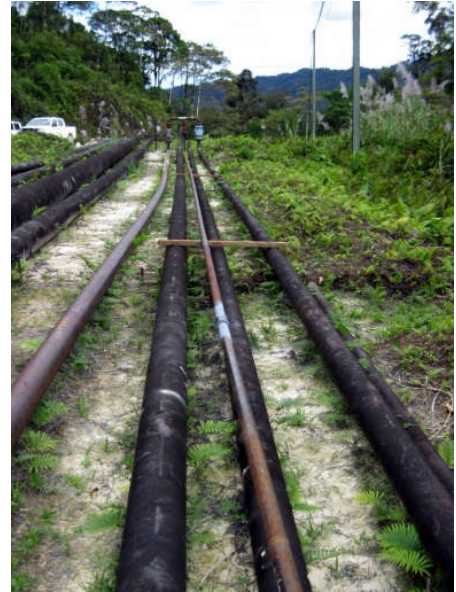
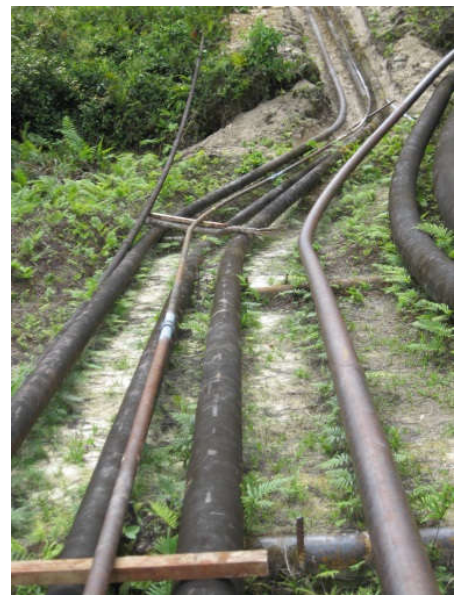
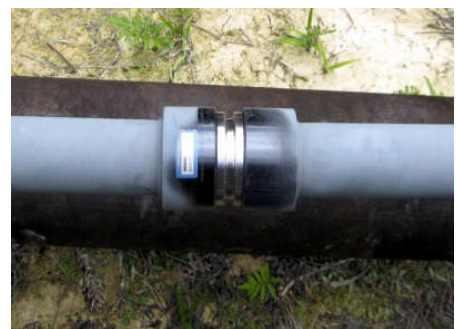
When external corrosion caused a pin-hole leak in a gas injection line; they decided this was another application for Lokring fittings. Is pipeline operates at 2000 PSI, is in a remote location and difficult to purge and ensure safe for welding.

A new pipe spool was cut to length and ends cleaned and prepped ready for installation. Once de-pressured, the defect section was cut-out and the new spool installed. Two Lokring repair couplings were used and the complete work conducted under a cold work permit with no welding required.
