Another Problem Solved by PipeServ

Location: Queensland, Australia

Application: CSG High Point Vent Repairs

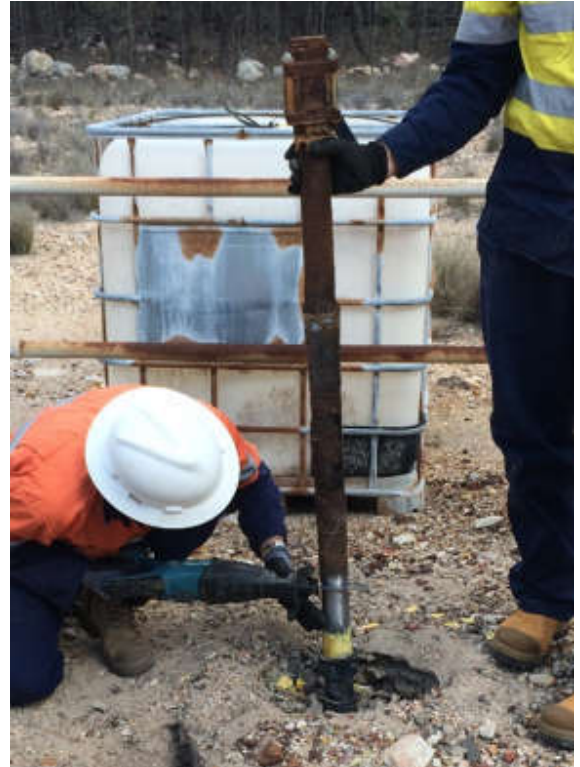
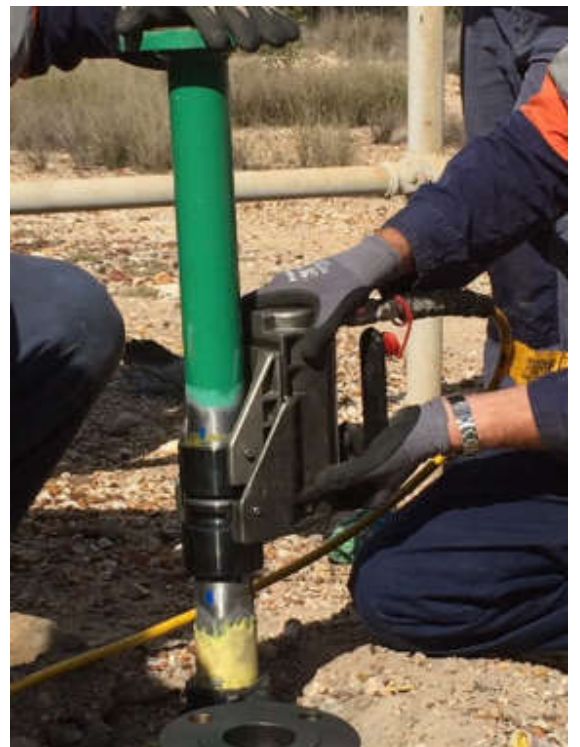
PipeServ was asked to assist with a cost effective solution in the repair of CSG high point vent risers that require replacement/repair due to corrosion within the ground interface area.

Our solution was for the hand excavation to expose the corroded steel riser to allow for cold-cutting the riser. The use of Lokring pipe couplings allowed the new riser to be installed within a few minutes and all works could be completed under a cold work permit.

Lokring fittings provided for significant cost savings but more importantly was the added safety when no excavation, welding, purging and flushing was required. With welding removed, so are the added costs and safety concerns of hot work. Lokring fittings are ASME qualified, weld equivalent pipe fittings used for both pipe repair and construction.
