Another Problem Solved by PipeServ

Location: Melbourne, Australia

Application: Propylene Drain Line Repair

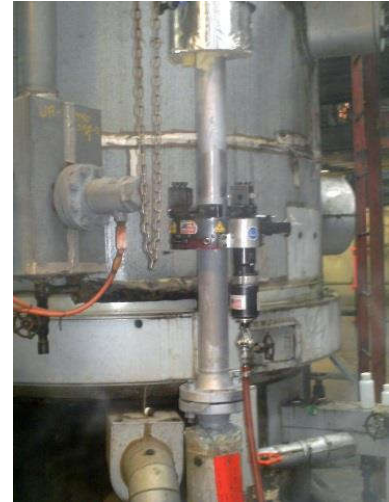
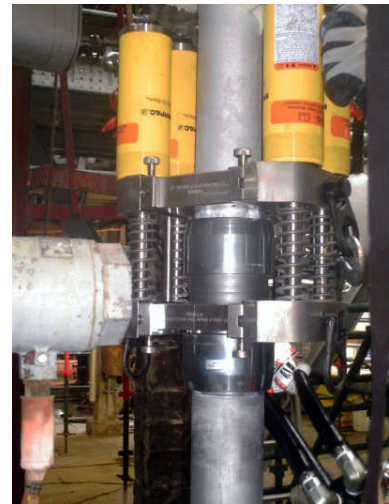
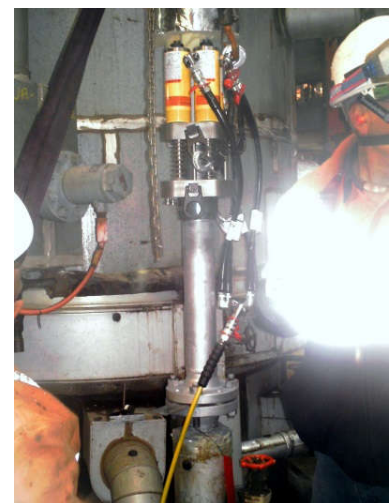
PipeServ was asked to urgently assist in getting this 3” propylene pipeline repaired and back into operation. This section of pipe and flange were found needing replacement and as quick as possible; hence the phone call on a Saturday to check on available Lokring fittings and tooling.

Due to the product and location; the preference was to complete the work without any welding. The solution was to use a Lokring pipe coupling to install the replacement pipe spool. The pipeline was cut using a pneumatic pipe cutter and PipeServ assisted with the Lokring installation. All works completed under a cold work permit. The complete scope, including pipe cutting and installation, was completed in four (4) hours.

The Lokring LTCS-333 Coupling was selected because of the NACE compliant materials and suitability for this service.
