Another Problem Solved by PipeServ

Location: Papua New Guinea

Application: Repair to Pipeline Erosion

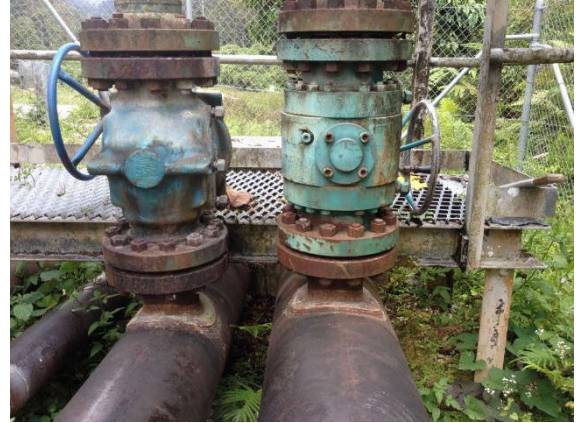
PipeServ was able to offer a solution in repairing a pipeline with internal wall loss. Increased levels of sand from a well site had caused significant internal erosion at this tie-in point. Any further wall loss would cause this pipeline to be de-rated and cause significant losses to production.

INTERNAL EROSION CAUSED BY SAND

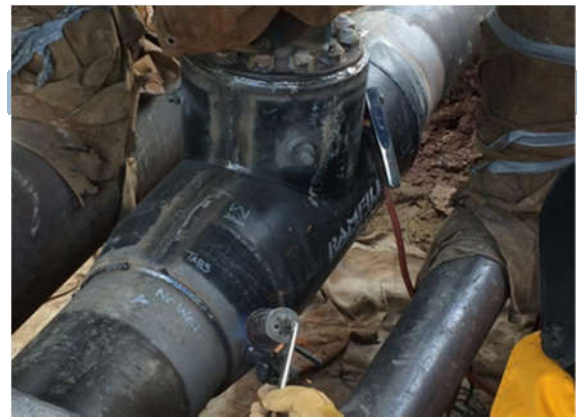
SLEEVE FITTED AND BEING WELDED

The RAMFILL-B+RE epoxy filled sleeve was offered by PipeServ. The Ramfill sleeve would encapsulate the 12" pipeline but also the branch and flange (below the valve). Once welded; the sleeve will be filled with liquid epoxy, filling the annulus between pipe and sleeve.

- * Grit blast the pipeline and branch.
- * Apply RAM paste as corrosion inhibitor.
- * Fit the RAM sleeve and complete welds.
- * NDT to all welds.
- * Pump RAM liquid epoxy to fill the sleeve.

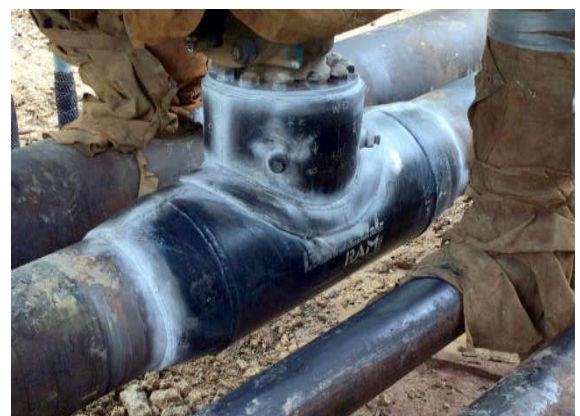
RAMFILL SLEEVE FULLY INSTALLED: WELDED, NDT INSPECTED & FILLED WITH RAM LIQUID EPOXY.

The RAMFILL Repair Sleeve provided full encapsulation repair and is rated to the pipeline design pressures and temperatures as specified by the client. The epoxy filler is multi-purpose; providing for corrosion protection, leak sealing and for load transfer of pipeline to sleeve. This repair is permanent and was completed on-line with no loss to production.
