## Another Problem Solved by PipeServ

**Location: Papua New Guinea**

**Application: Repair to Leaking Clamp**

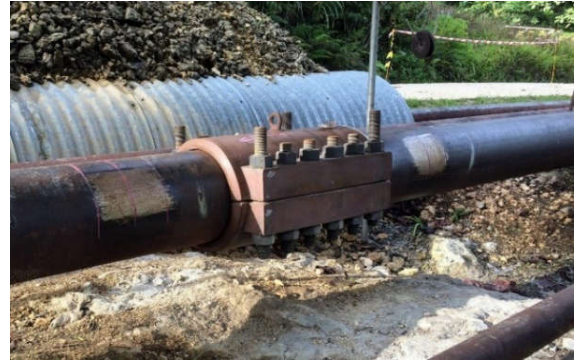
PipeServ was able to offer a solution in repairing a pipeline repair clamp that had begun leaking from the seals. This DN200 ANSI 600# oil pipeline and could not be shut down without significant cost to production.

PIPELINE WITH REPAIR CLAMP BUT NOW LEAKING FROM THE SEALS.

After further consideration and several risk assessments; the decision was that the RAMFILL Repair Sleeve was the most cost effective and safe solution. The installation included:

- Apply RAM epoxy paste to seal the leak.
- Grit blast the clamp and pipeline.
- Apply RAM paste to clamp and pipe.
- Fit the RAM sleeve and weld.
- NDT of all the welds.
- Pump RAM liquid epoxy to fill the sleeve.

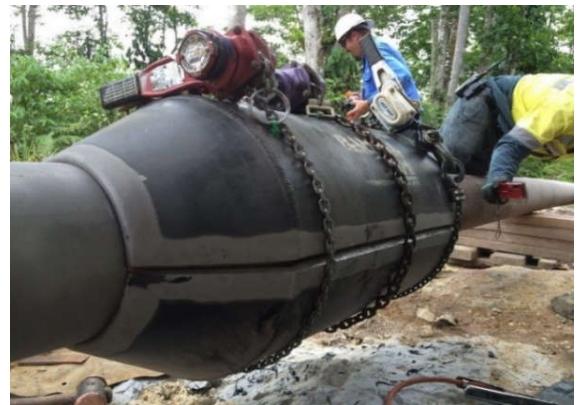
LEAK SEALED AND RAMFILL SLEEVE FITTED READY FOR WELDING.

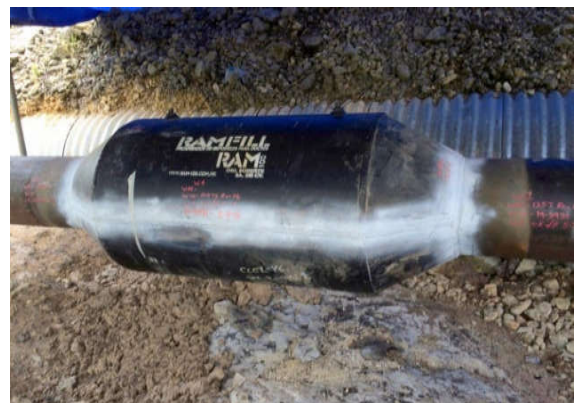
RAMFILL SLEEVE FULLY INSTALLED: WELDED, NDT INSPECTED & FILLED WITH RAM LIQUID EPOXY.

The RAMFILL Repair Sleeve provided full encapsulation repair and is rated to the pipeline design pressures and temperatures as specified by the client. The epoxy filler is multi-purpose; providing for corrosion protection, leak sealing and for load transfer of pipeline to sleeve. This repair is permanent and was completed on-line with no loss of production.
