Another Problem Solved by PipeServ

Location: Papua New Guinea

Application: Valve Installation

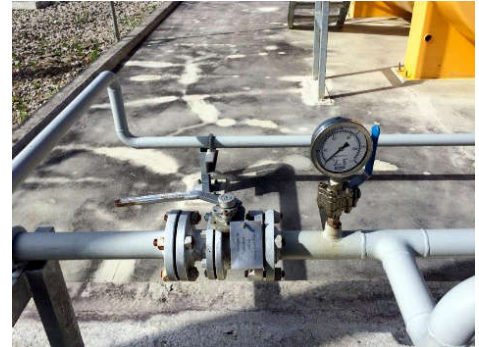
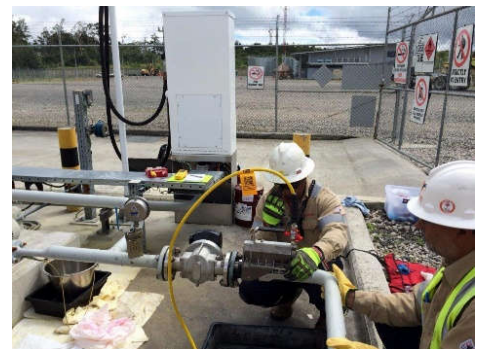
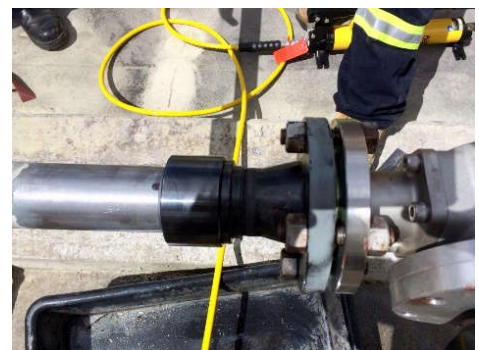
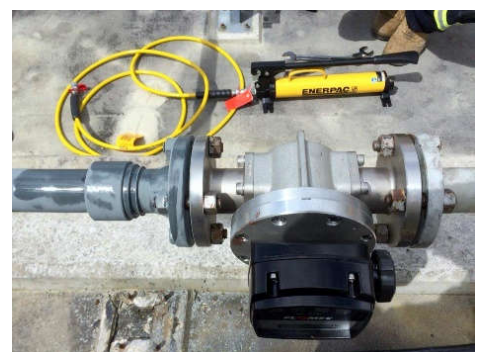
LOKRING 2" 150# FLANGED FITTINGS

PipeServ was asked to assist with the modification of diesel piping to allow for a new valve to be installed. This was to replace an existing valve but the new valve was longer and the pipe needed to be modified to suit and a new flange installed.

Having previous experience with Lokring fittings; the pipeline owner went ahead with the installation using a Lokring flanged fitting. Trained staff then proceeded to complete the installation and commissioning of the valve.
