Another Problem Solved by PipeServ

Location: Melbourne, Australia

Application: Steam Line Elbow Replaced

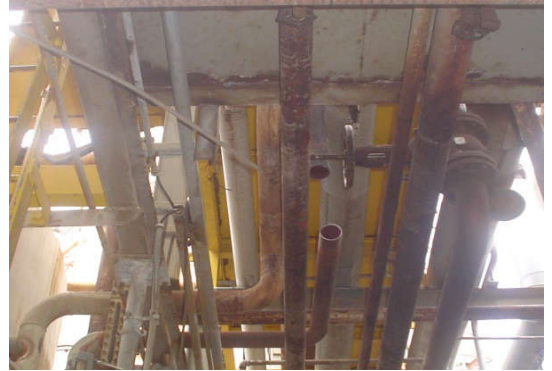
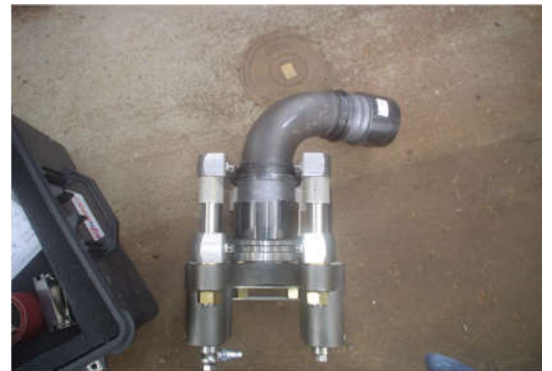
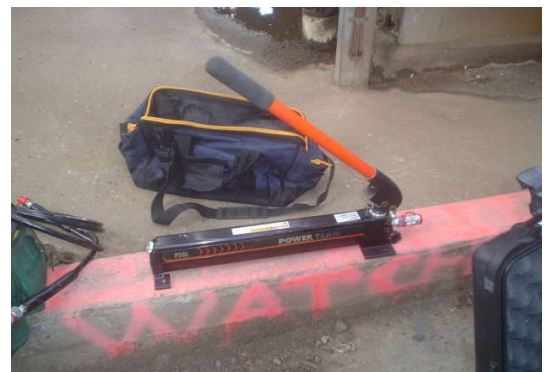
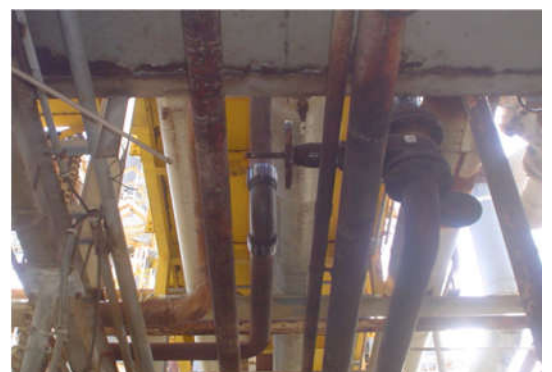
PipeServ was asked to assist in the cut-out and replacement of a steam line pipe elbow. Inspection of the elbow had confirmed that internal erosion/corrosion required the elbow be replaced.

Traditionally; this would have been completed by cutting out and welding of new spooling but Management had requested the use of Lokring fittings. This was the first time the contractor had installed the Lokring elbow and they requested PipeServ to assist in the installation.

The decision was to use a Lokring pipeline elbow and this resulted in the following benefits:

- Lokring complete repair was costed as \$3000
- Steam outage was reduced to 3hrs.
- Indirect savings from reduced process outage.
- Work was completed under Cold Work Permit.
- Two man installation.
- No scaffolding required (scissor lift was used).
- Reduced risk of injury or incident.
